Contract #: 04-0120F4Cty: SF/ALA Rte: 80 PM: 13.2/13.9File #: 13.28**WELDING INSPECTION REPORT****Resident Engineer:**Pursell, Gary**Address:** 333 Burma Road**City:** Oakland, CA 94607**Report No:** WIR-006750**Date Inspected:** 15-May-2009**Project Name:** SAS Superstructure**OSM Arrival Time:** 1100**Prime Contractor:** American Bridge/Fluor Enterprises, a JV**OSM Departure Time:** 1830**Contractor:** Oregon Iron Works Clackamas, Or.**Location:** Clackamas, OR**CWI Name:** Steve Barnett**CWI Present:** Yes No**Inspected CWI report:** Yes No N/A**Rod Oven in Use:** Yes No N/A**Electrode to specification:** Yes No N/A**Weld Procedures Followed:** Yes No N/A**Qualified Welders:** Yes No N/A**Verified Joint Fit-up:** Yes No N/A**Approved Drawings:** Yes No N/A**Approved WPS:** Yes No N/A**Delayed / Cancelled:** Yes No N/A**Bridge No:** 34-0006**Component:** Hinge-K Components**Summary of Items Observed:**

Summary of Items Observed: On this date, Caltrans Quality Assurance Inspector (QA) Clete Henke was present at Oregon Iron Works, Inc. (OIW) in Clackamas, OR for observation of fabrication of the Hinge K Pipe Beams and related activities including in process welding and OIW Quality

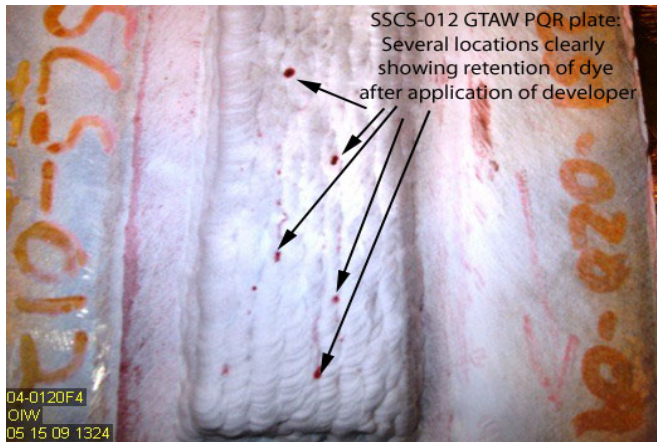
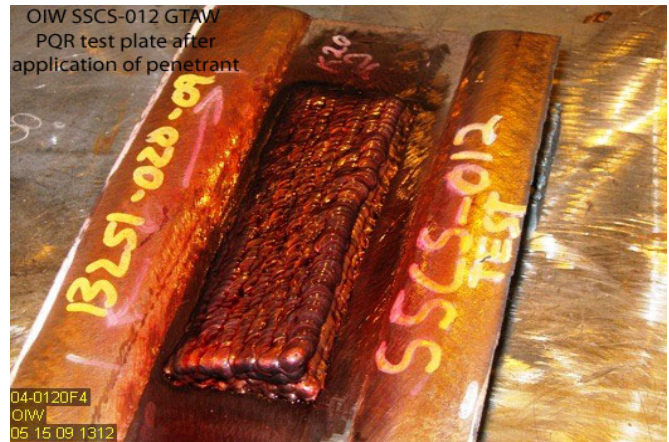
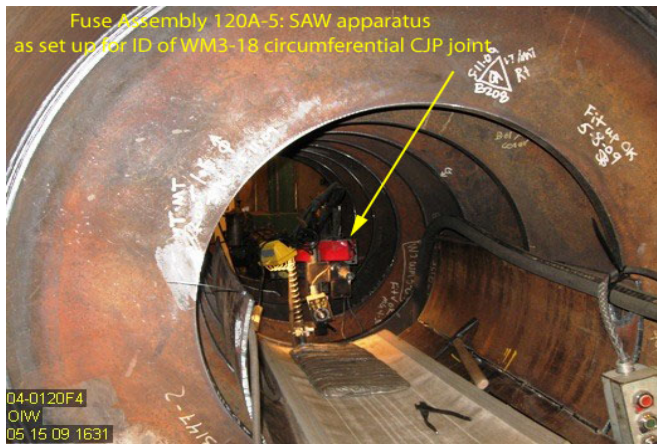
Shortly after arrival, the QA Inspector was contacted by OIW Lead QC Inspector Mike Gregson and informed that Dye Penetrant (PT) Testing was about to be initiated on Gas Tungsten Arc Welding (GTAW) procedure qualification record (PQR) plate identified as SSCS-012. The QA Inspector met OIW QC Inspector Jose Salazar and observed as Mr. Salazar performed the testing described above. After the application of developer, there were several indications apparent and Mr. Salazar indicated that OIW production intended to grind the locations in question and re-test the affected areas. After the locations were ground, the QA Inspector observed as OIW Lead QC Inspector Mike Gregson performed the testing again with multiple indications still visible. Mr. Gregson indicated that OIW production would likely elect to have the test plate machined down to the minimum level of reinforcement and tested again in an attempt to achieve an acceptable result. As of this date, the results of the PT described above are not in compliance with contract requirements.

The QA Inspector observed in-progress Submerged Arc Welding (SAW) at Inside Diameter (ID) portion of circumferential weld joining a124-14 to a124-2 identified as WM3-18 on approved shop drawings. OIW welder Bui Liem (WID B10) deposited SAW fill and cover passes in the flat (1G) position in accordance with approved welding procedure 4020. The QA Inspector noted the OIW welder was maintaining continuous preheat utilizing two torches. The QA Inspector observed OIW QC Inspector Steve Barnett regularly monitoring and recording the in process SAW parameters. The QA Inspector also intermittently observed the in process welding parameters and determined that the SAW parameters and minimum preheat/interpass temperature appeared to be in general compliance with the contract requirements -- (33 volts, 525 amperes, 457mm/min travel speed).
